NATURAL PROCESSES IN THE AREA OF THE FORMER KAKHOVSKE RESERVOIR AFTER THE DESTRUCTION OF THE KAKHOVKA HPP

VYSHNEVSKIYI VIKTOR I.^{1,2*}, SHEVCHUK SERHII A.²

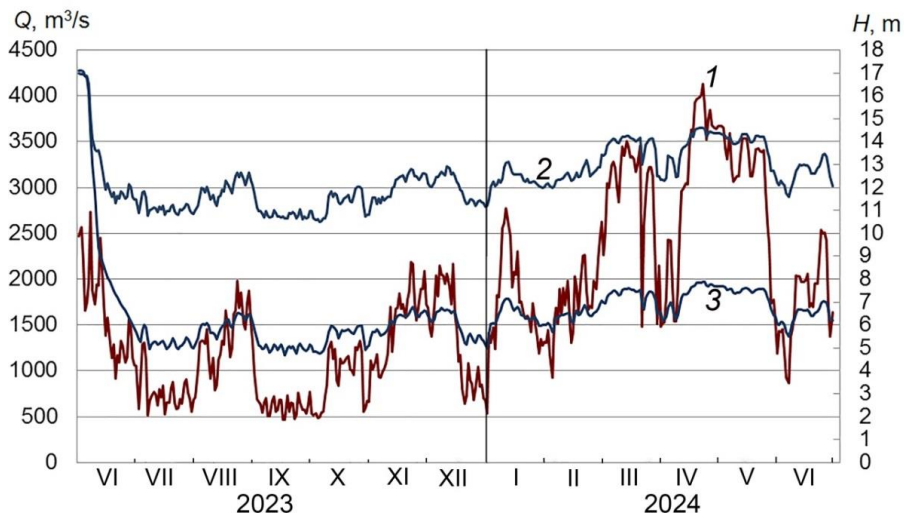
Fig. 6: The discharges at the Dnipro HPP (1) during period from June 1, 2023 till June 30, 2024 and the water level at Rozumivka (2) and Nikopol (3) stations for the same period

In the following period, the water level in the area of the former reservoir began to depend mainly on the water discharge at Dnipro HPP located upstream. The small water discharge was observed in September, when its mean value was 626 m³/s. After that, as a result of rains in the upper reaches of the river, the discharges increased. In October, it was 902 m³/s, in November – 1,530 m³/s, in December – 1,360 m³/s. The highest water level at Rozumivka station (12.91 m a.s.l.) in the second half of 2023 was registered on December 11, 2023. These measured data are shown in Fig. 6. Besides, in this figure is presented calculated level at Nikopol station according to the dependence between discharges and water level in natural conditions.

The significant spring flood in form of two waves on the Dnipro River was observed in 2024. The maximum discharge of the first wave (3,500 m³/s) at Dnipro HPP was registered on March 15, 2024; the peak of the second wave with maximum discharge 4,130 m³/s was registered on April 23, 2024. At this time, the increase of water level was observed in the area of the former reservoir. The highest water level (14.62 m a.s.l.) at Rozumivka station was observed on April 21 and on April 23, 2024.

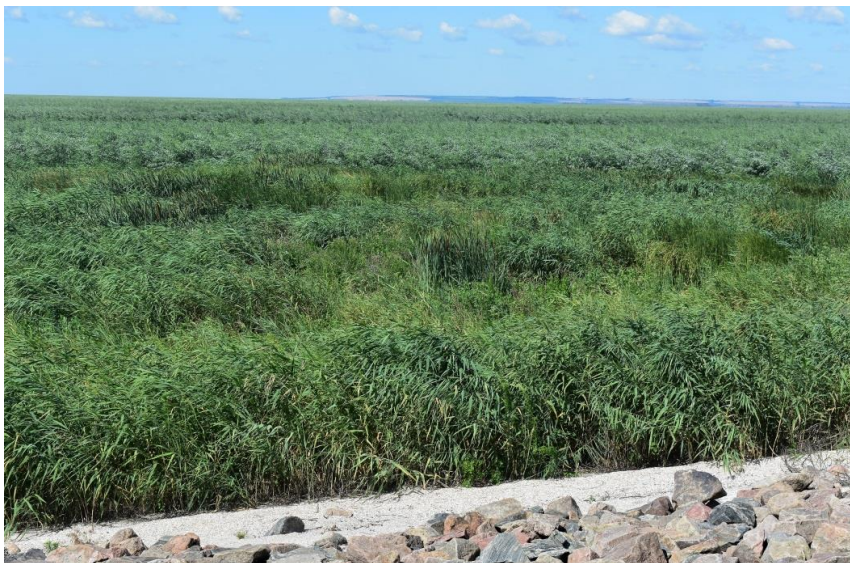
Fig. 9: The overall view of the former Kakhovske reservoir near the village of Malokaterynivka, 21.06.2024

The shore near the village of Malokaterinivka has a stone protection. The adjacent strip of shore is covered with sandy deposits. Alongside, a strip of reed (*Phragmites australis*) is located, and finally, a large area of the former reservoir is covered with willow, more precisely a hybrid of *Salix alba* and *Salix fragilis* (Fig. 9).

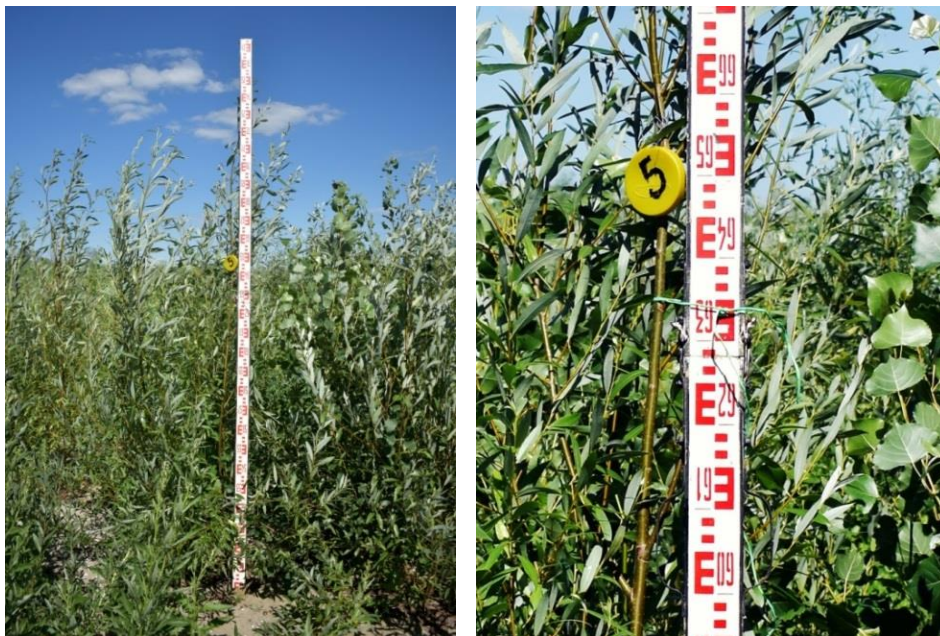
Fig. 11: The typical size of willow trees near the village of Bilenke, 21.06.2024

The size of the willows on the opposite right bank of the former reservoir on June 21, 2024 was much smaller. The average height of the trees was 2.7 m, the mean diameter at a height of 1.5 m was 13 mm. Poplar trees (*Populus nigra*) were also found in this area (Fig. 11).

Such differences of typical size of trees can be explained by differences in bottom sediments. The trees near the village of Bilenke began to grow on sandy sediments which were well washed by the river flow before the emptying of the reservoir.
